## 737 GRAPHITE COMPOSITE FLIGHT SPOILER FLIGHT SERVICE EVALUATION

FIRST ANNUAL REPORT  
JULY 1973 THROUGH MARCH 1975

Prepared under contract NAS1-11668 by  
BOEING COMMERCIAL AIRPLANE COMPANY  
P.O. Box 3707  
Seattle, Washington 98124

May 1975

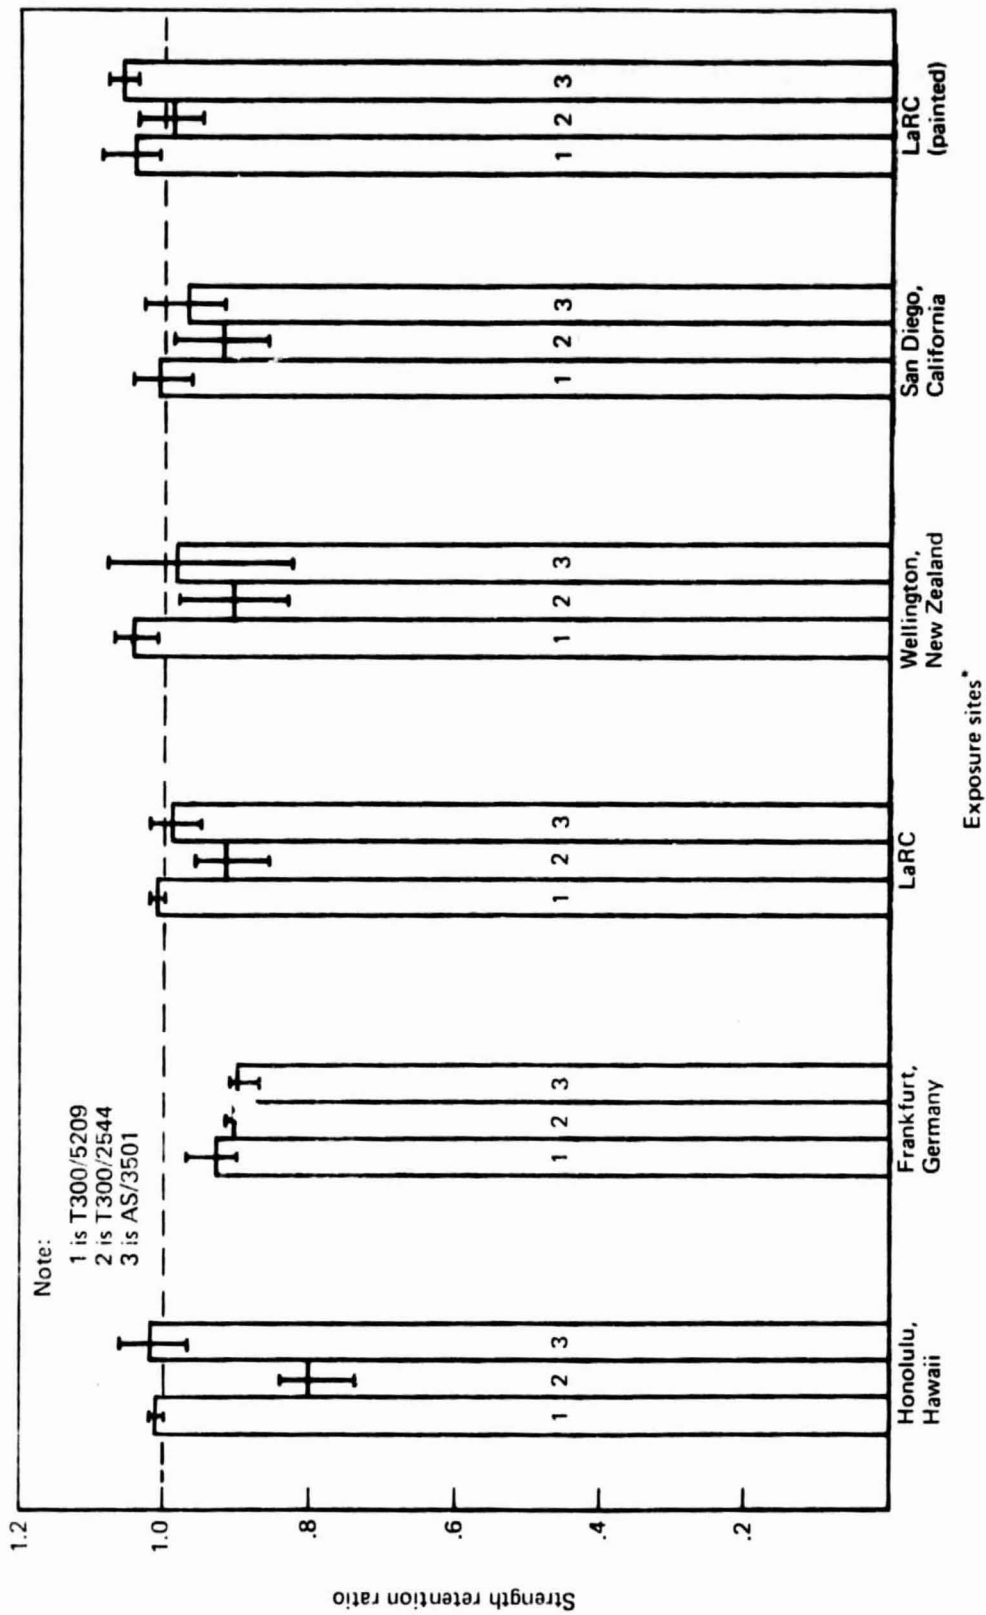
Figure 19.—Interlaminar Shear Strengths of Graphite-Epoxy Composites After 1-Year Outdoor Ground Exposure

Tables 6, 7, and 8 give results of tests on shear, flexure, and compression specimens of the three graphite-epoxy material systems following 1 year of environmental exposure at five of the six sites. Comparisons with the test results on unexposed baseline specimens are made in the bar graphs of figures 19, 20, and 21. These three material systems show generally less than 10% change in mechanical properties. Moisture pickup by these materials has been generally less than 1% based on changes in specimen weight. Although the change in material properties is about the same order of magnitude as the change in static strength and stiffness of the spoilers, neither is large enough to be significant by itself. The overall effects of the first year of the outdoor exposure program are summarized in table 9.
